Enabling the Keypad on Vertex VX-427A Radios

Brian Rasnow (brian@rasnowpeak.com)

Summary. The Vertex Standard VX-427 radio (Fig. 1) is programmed through Vertex's CE89 software. The later generation VX-427A requires CE94 software. CE94 in its default configuration disables the radio's keypad. This paper describes a hack to enable it.

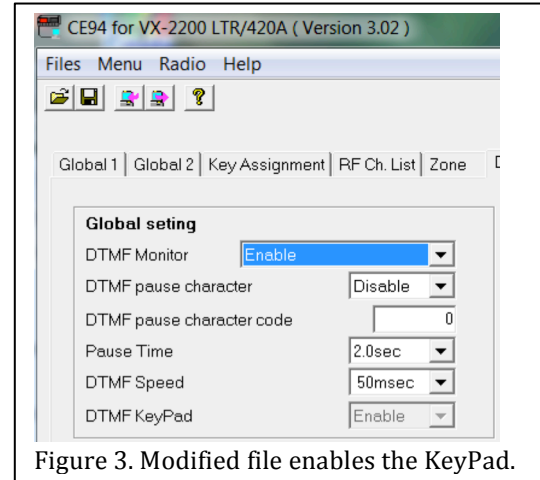
This suggests changing the 42₁₆ at location 600₈ to 62₁₆ might enable DTMF. Although there are various Unix tools to edit binary files (along with low level fopen/fread/fwrite), a freeware hex editor for OSX called iHex is an easy download from Apple's AppStore. Flipping that bit and saving changed the state of CE94 (Figure 3).

Figure 3. Modified file enables the KeyPad.
